DEPARTMENT OF TRANSPORTATION

Quality Assurance and Source Inspection

Contract #: 04-0120F4Cty: SF/ALA Rte: 80 PM: 13.2/13.9File #: 69.28**WELDING INSPECTION REPORT****Resident Engineer:** Siegenthaler, Peter**Address:** 333 Burma Road**City:** Oakland, CA 94607**Report No:** WIR-017863**Date Inspected:** 16-Oct-2010**Project Name:** SAS Superstructure**OSM Arrival Time:** 700**Prime Contractor:** American Bridge/Fluor Enterprises, a JV**OSM Departure Time:** 1900**Contractor:** Zhenhua Port Machinery Company, Ltd (ZPMC), Changxing Island **Location:** Shanghai, China**CWI Name:** An Qing Xiang**CWI Present:** Yes No**Inspected CWI report:** Yes No N/A**Rod Oven in Use:** Yes No N/A**Electrode to specification:** Yes No N/A**Weld Procedures Followed:** Yes No N/A**Qualified Welders:** Yes No N/A**Verified Joint Fit-up:** Yes No N/A**Approved Drawings:** Yes No N/A**Approved WPS:** Yes No N/A**Delayed / Cancelled:** Yes No N/A**Bridge No:** 34-0006**Component:** Orthotropic Box Girder(OBG)**Summary of Items Observed:**

WELDING INSPECTION REPORT

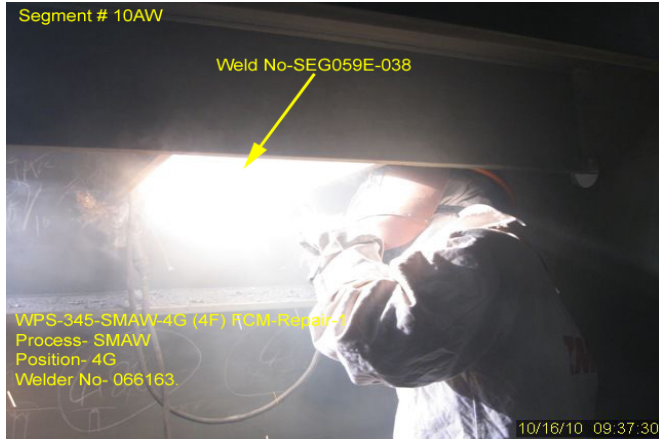
Segment # 10AW

This QA inspector observed ZPMC qualified welding personnel identified as 066163 perform Shielded Metal Arc Welding (SMAW), weld joint identified as SEG059E-038; located On Orthotropic Box Girder (OBG) Corner Assembly Deck Plate to Stiffener (X3S & X8E) Weld; excavated weld due to Flatness rejected areas. The Critical Welding Repair Report (CWRR) was B-CWR2004. ZPMC Quality Control (QC) is identified as Mr. Zhou Peng. The welding variables recorded by QC appeared to comply with the Applicable WPS-345-SMAW 4G (4F) FCM Repair-1 See the attached Photo.

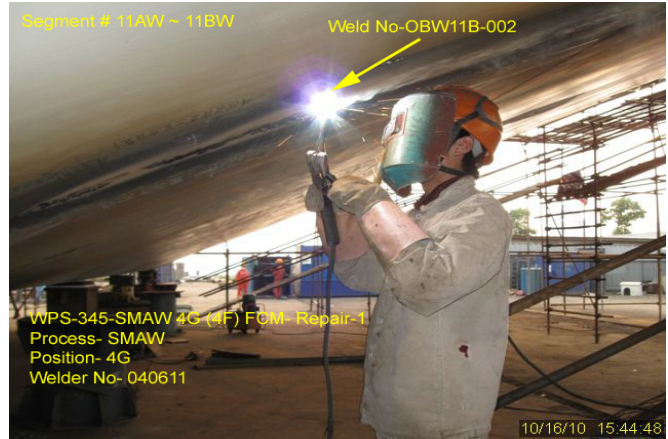
Segment # 11AW ~ 11BW

This QA inspector observed ZPMC qualified welding personnel identified as 040611 perform Shielded Metal Arc Welding (SMAW), weld joint identified as OBW11-005; located On Orthotropic Box Girder (OBG) Bottom Plate to Bottom Plate Transverse CJP Weld; excavated weld due to Ultrasonic rejected areas. The Welding Repair Report (WRR) was B-WR15990. ZPMC Quality Control (QC) is identified as Mr. Zhou Peng. The welding variables recorded by QC appeared to comply with the Applicable WPS-345-SMAW 4G (4F) FCM Repair-1 See the attached Photo.
